**Property Inspection Report**

**SAMPLE REPORT  
NO PHOTO**

**Report Number:** 000000-A  
**Property Address:** Relatively New Condominium  
**Client(s):** First Time Homebuyer

**Building Description:** Condominium / Townhouse  
**Approximate Age:** Year Built: 2008 (Based on MLS information)  
**Front of the Building Generally Faces:** Southeast

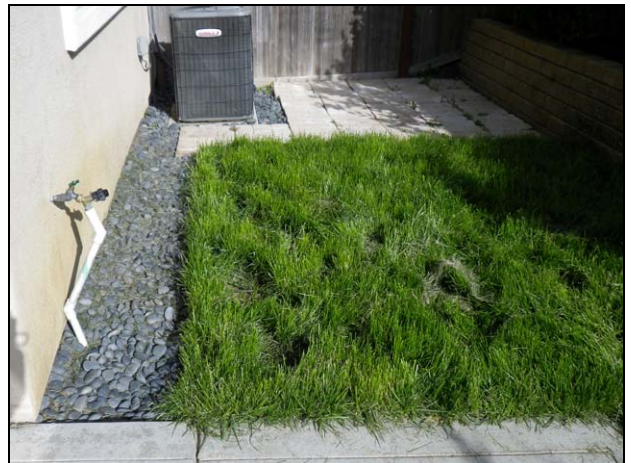
*Needed Maintenance:* The soil needs to be re-graded at the back yard to slope and drain away from the building and toward the drainage inlet.

Keep the underground drain inlets clear of foliage and debris.

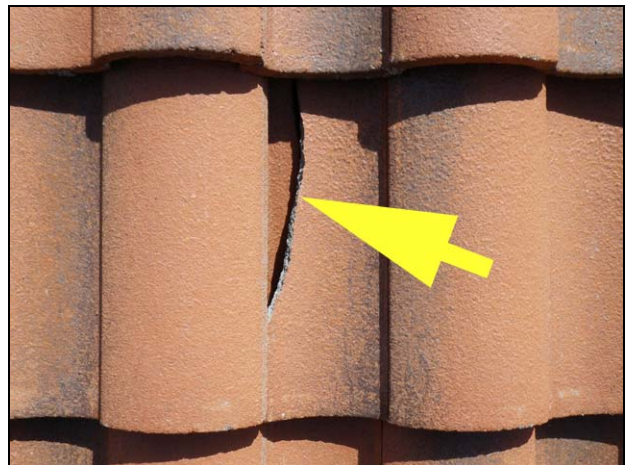
*Defect / Malfunction:* A few cracked and broken roof tiles were noted.

**Recommendation:** Further evaluation and repairs/corrections be performed as needed by a licensed roofing contractor.

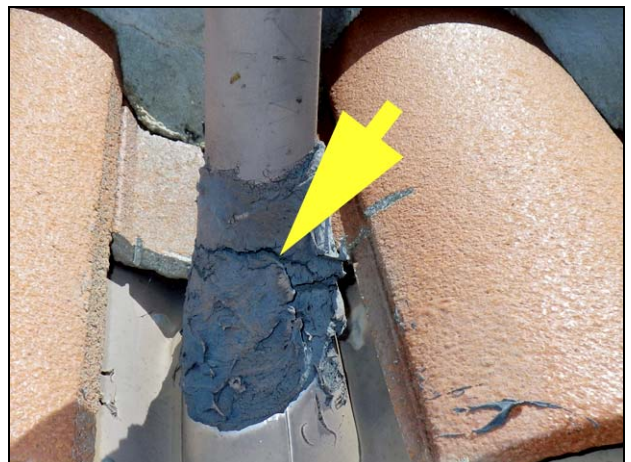
Deteriorated sealant/mastic was noted at the vent pipe flashings.

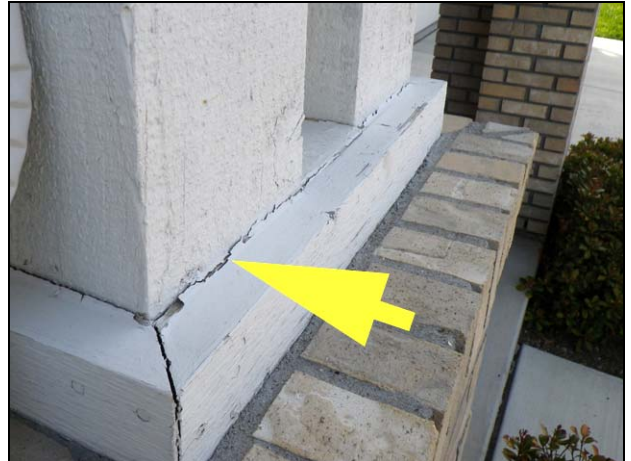
Deteriorated caulking was noted in places on the wood trim.

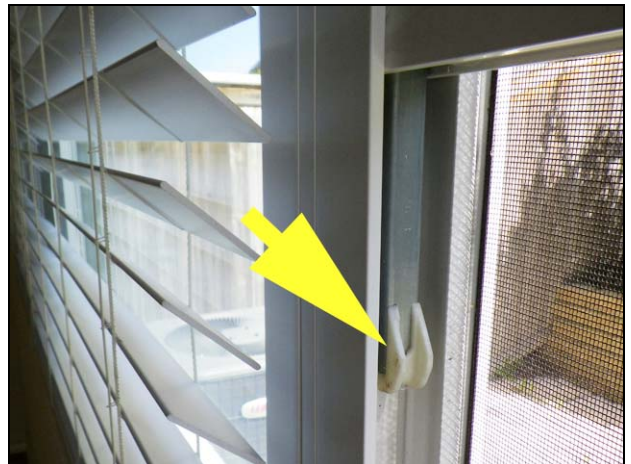
*Health & Safety:* Faulty/disconnected springs were noted at the kitchen, living room, Jack & Jill bathroom, and master bathroom single-hung windows.

**Recommendation:** Further evaluation and repairs/corrections be performed as needed by a licensed glazing contractor.

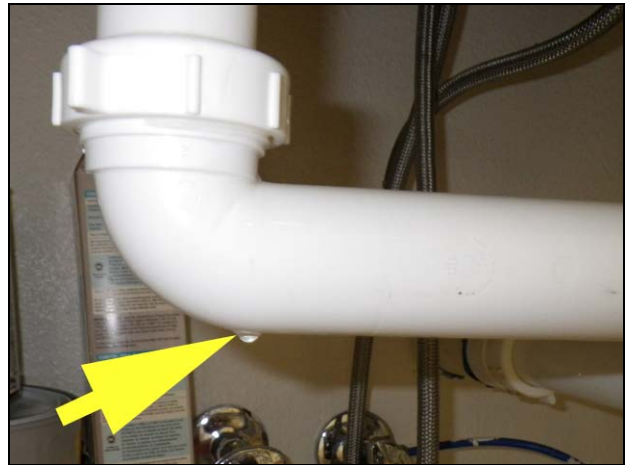
*Defect / Malfunction:* Leaking was noted at the kitchen sink drain line.

**Recommendation:** Further evaluation and repairs/corrections be performed as needed by a licensed contractor or other appropriately qualified specialist.

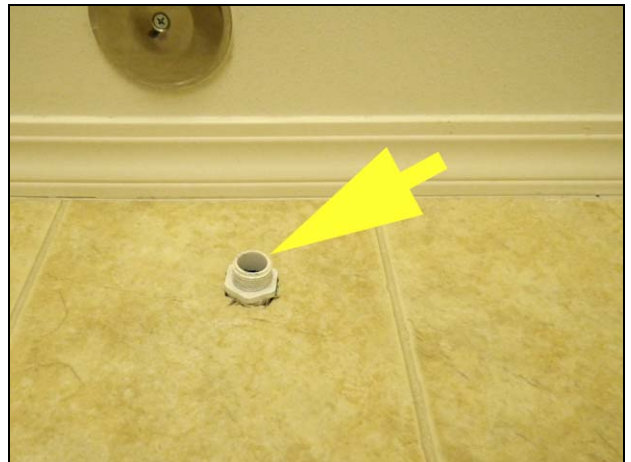
**Defect / Malfunction:** There is no proper inlet at the overflow drain pipe in the laundry room floor. The drain should be flush with the floor and covered with a proper drain grate or connected to an overflow catch pan.

**Recommendation:** Further evaluation and repairs/corrections be performed as needed by a licensed contractor or other appropriately qualified specialist.

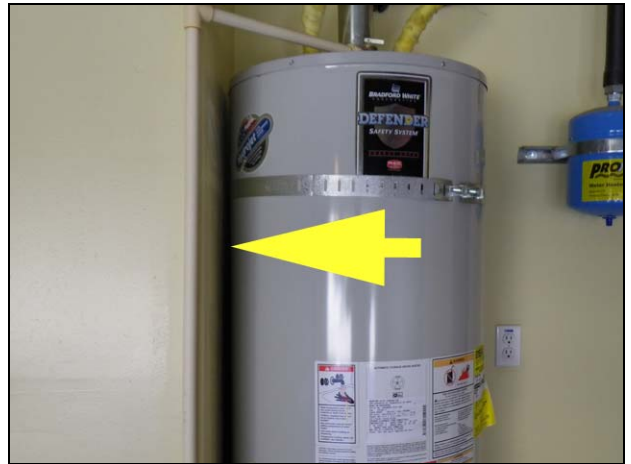
*Health & Safety:* The water heater is not braced tight to the left side wall. Spacers or blocking are needed between the unit and the wall.

**Recommendation:** Further evaluation and repairs/corrections be performed as needed by a licensed contractor or other appropriately qualified specialist.

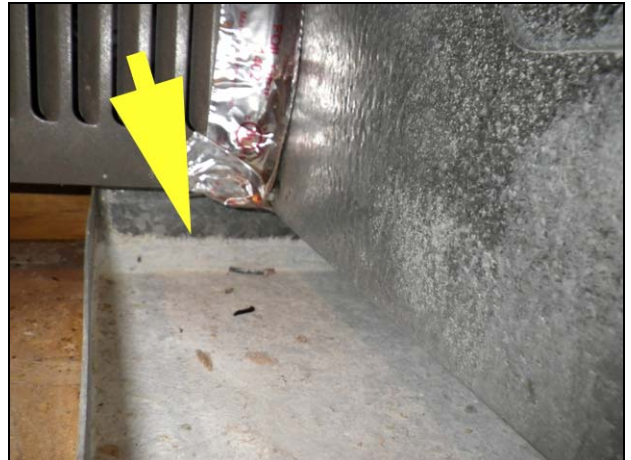
*Defect / Malfunction:* Stains and evidence of past moisture were noted in the air conditioner secondary catch pan in the attic. This is evidence that the primary condensate drain is not functioning.

**Recommendation:** Further evaluation and repairs/corrections be performed as needed by a licensed warm-air heating, ventilating and air-conditioning contractor.

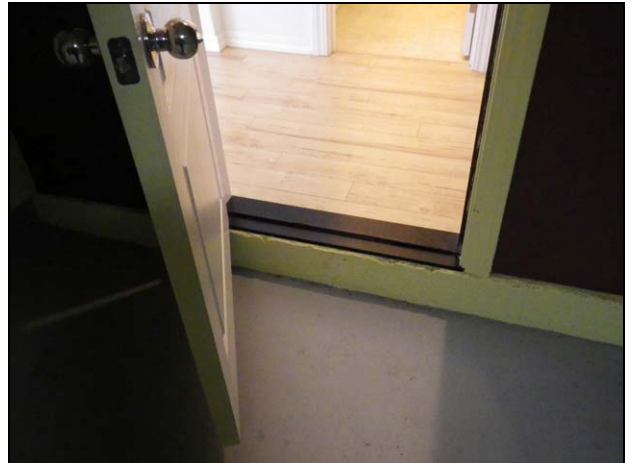
*Health & Safety:* The garage interior entrance door improperly swings open over a step. This is a potential trip hazard.

**Recommendation:** Further evaluation and repairs/corrections be performed as needed by a licensed contractor.
